Are tungsten-based nuclear fusion components truly invisible to x-ray inspection?

To cite this article: Triestino Minniti and Heather Lewtas 2022 *Nucl. Fusion* **62** 066003

UKAEA-United Kingdom Atomic Energy Authority, Culham Science Centre, Abingdon, OX14 3DB, United Kingdom of Great Britain and Northern Ireland

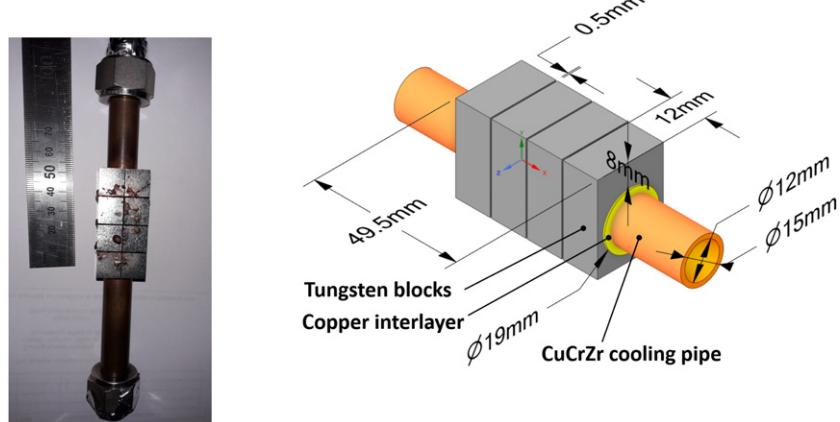
Figure 1. (Left panel) Photograph of the DEMO divertor target studied by means of 6 MeVs energy XCT. (Right panel) A schematic drawing with the relevant dimensions of the sample.

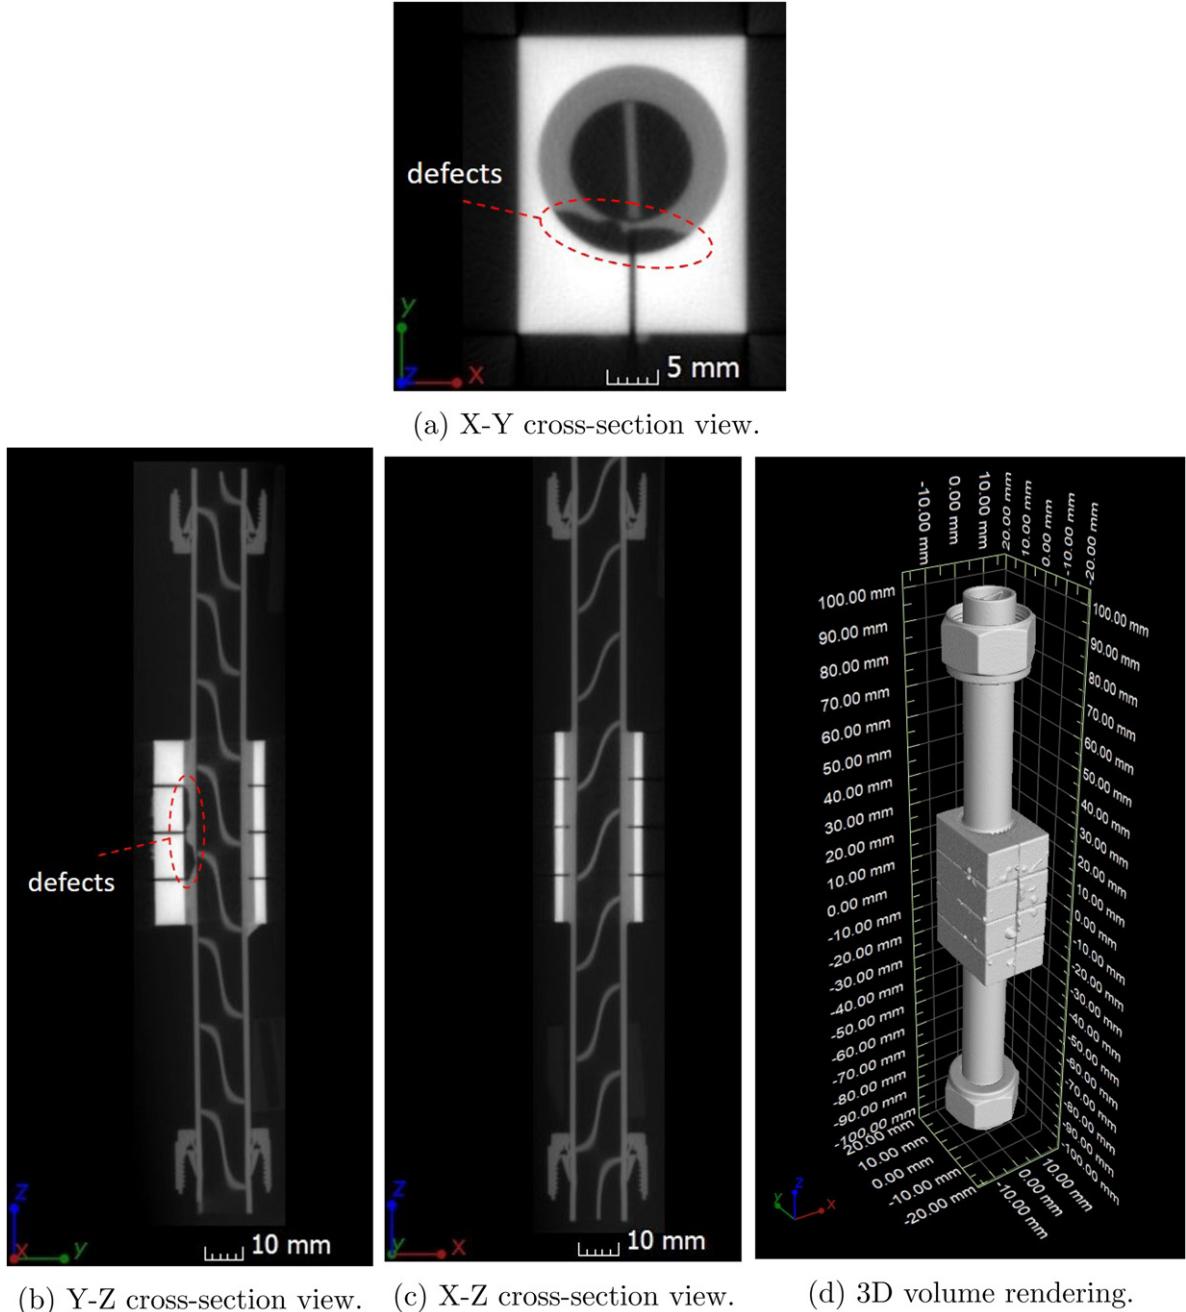
Figure 3. Cross-section views and 3D volume rendering of the DEMO divertor mock-up extracted from XCT data at MeV energy range.

to the component is clearly visible from the $x-y$ and $y-z$ cross-section images which have revealed multiple failures of the inner CuCrZr alloy pipe and the oxygen-free high conductivity (OFHC) copper interlayer. Damage to the component is particularly located in the proximity of the two central monoblocks. Melted materials caused by the HHF load have been partially deposited on the external W tile surface and they are visible in the 3D volume rendering image of the specimen in figure 3(d) as well as on the picture of the sample reported in the left panel of figure 1.

The $x-y$ cross-section image of figure 3(a) has further revealed a complete loss of the structural integrity of the pipe in the proximity of the joints between monoblocks where the

pressure relief after boiling has resulted in the formation of some holes in the pipe with the subsequent loss of coolant. The good spatial resolution achieved in the tomography scan is also testified by the level of detail in the reconstruction of the threads of the two pipe fittings utilised to attach the mockup to the external cooling loop during the HHF test on HIVE, and visible in the $y-z$ and $x-z$ cross-section images of figures 3(b) and (c). Further, in the scan we been able to resolve details of

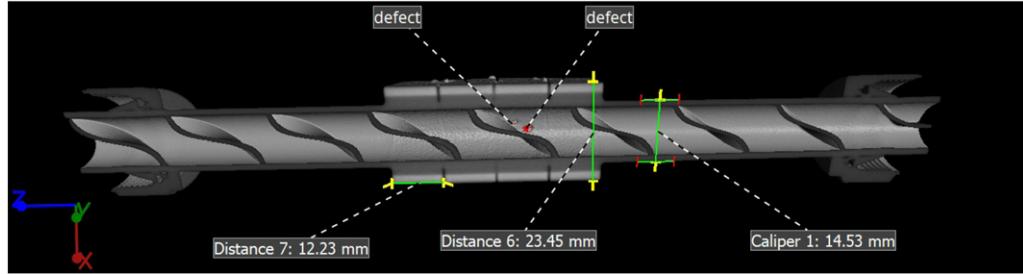
Figure 4. Volume rendering of the inner structure of the DEMO divertor mock-up where holes in the CuCrZr pipe have been highlighted ('defect' label). Metrology checks of some dimensions of the component were super-imposed as well for completeness.

the inner structure of the divertor target mockup and the helical swirl tape that runs through the entire length of the cooling pipe as shown in the cross-section images of figures 3(b) and (c), and in the subsequent figure 4. Figure 4 shows a 3D rendering of the divertor mockup where only about half of the component has been considered, this allows us to better understand the location of some of the holes present in the CuCrZr pipe, indicated in the figure with the label named 'defect'.

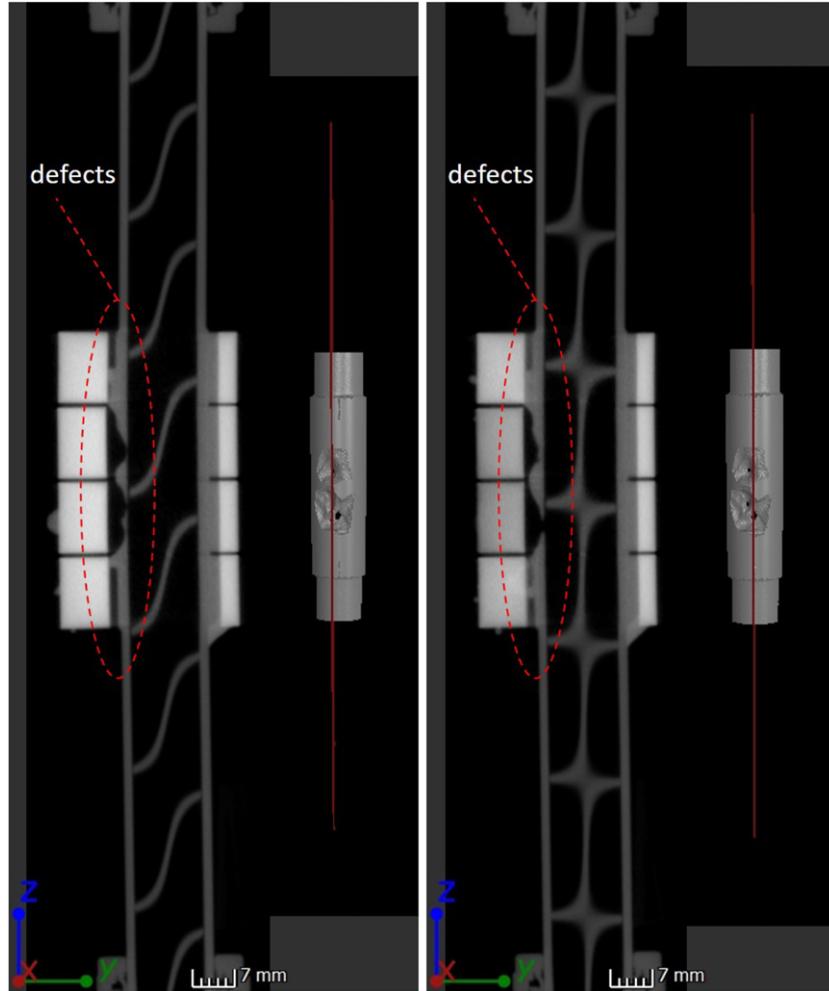
Figure 5. $y-z$ cross-section views of the component in coincidence of the holes detected in the CuCrZr pipe. Left panel reports the first two pipe holes which are aligned vertically along the z axis, rather the third one is shown separately in the right panel of the figure. An insert displaying a 3D rendering of the component where W tiles has been masked (description provided in the main text) has been embedded in each panel for helping the reader localizing the cross-section image respect to the 3D rendering of the sample.

A better representation of the damage caused by failure during HHF load of the component has been achieved via virtual removal of the W tiles of the mock-up and obtained by masking with a cylindrical region of interest aligned in the respect to the pipe axis in the volume rendering of the sample. The result of this procedure is visible in the insert image embedded in each panel of figure 5. This image shows large melting regions in the OFHC copper interlayer and holes in the CuCrZr pipe of the specimen. Cross-section views depicted in figure 5 highlight the presence of three holes in the CuCrZr pipe which as previously said, are all located in the two central monoblocks of the divertor target. Two holes are visible in the $y-z$ cross-section shown in the left panel of figure 5 because they were vertically aligned along the z axis. The third hole in the CuCrZr pipe is then depicted in the $y-z$ cross-section image on the right panel of the same figure.

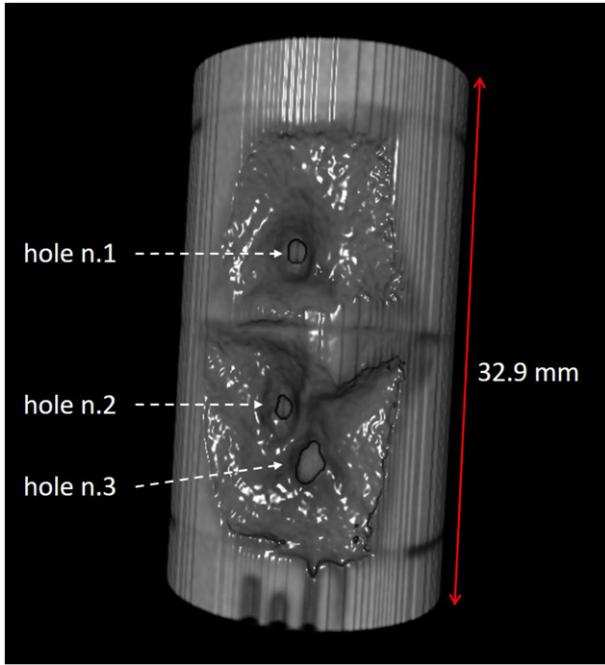
Figure 6. 3D rendering of the damage of the component caused after the HHF test performed on the HIVE facility.

To quantify the amount of material lost, a section of the volume close to the damage of the mock-up has been considered and shown in figure 6. This section has been obtained by extracting a sub-volume from the previous 3D rendering of the divertor target depicted in figure 5 where we hidden from the CT data the internal swirl tape volume with a similar procedure applied for masking the external W tiles discussed before. After manufacture and before any damage caused by the HHF load this selected section of the sample has a cylindrical shape with an external diameter of 19 mm if we sum the OFHC copper interlayer thickness of 4 mm to the pipe outer diameter

of 15 mm, an internal CuCrZr pipe diameter of 12 mm, and a length of 32.9 mm (as deduced by figure 6). With these dimensions its estimate overall volume is 5607.193 mm^3 within the assumption of a perfect cylindrical symmetry. Instead, the analysis of this section performed by means of VGSTUDIO MAX [21] has revealed a total volume of $2463.480 \pm 0.003 \text{ mm}^3$, i.e. a net loss of $3143.713 \pm 0.003 \text{ mm}^3$ of melted materials which have been partially deposited on the W tile surfaces of the component (see photo of the sample in figure 1).

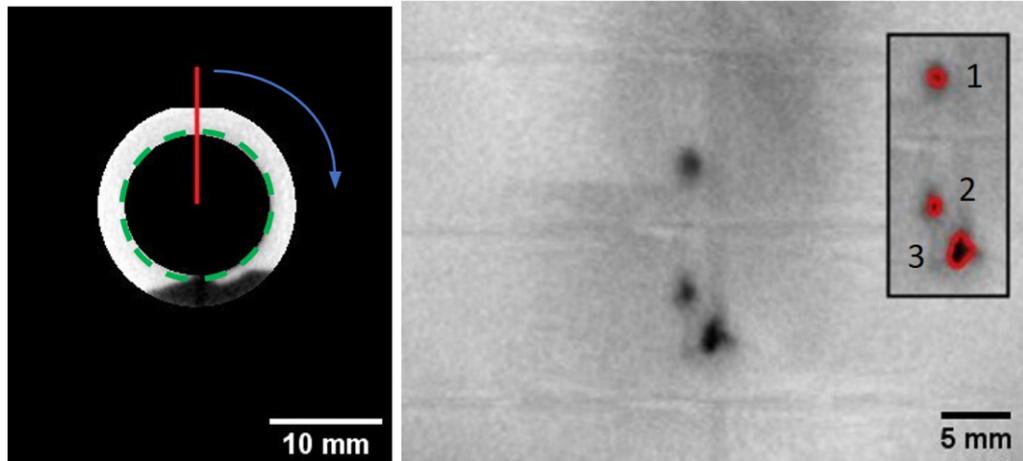
The quantification of the surface of each hole detected in the cooling pipe has followed a differ data analysis route because to its irregular geometrical shape, and it has been based on the idea of unrolling virtually the volume for the section of sample depicted in figure 6. The direction of unrolling is clockwise as highlighted by the blue arrow in the left panel of figure 7 which has been superimposed to a cross-section view of the analysed volume. From the resulting unrolled volume a slice close to the inner diameter of the pipe (following the dashed green line in figure 7) has been extracted and it is shown in the right panel of the same figure.

As expected, the holes in the CuCrZr pipe have an irregular shape difficult to evaluate with simple geometrical calculations. The computation of each hole dimension has required first the detection of its contour, after which the area could be evaluated knowing the pixel size. This has been done automatically by applying the ‘analyze particles’ plugin [22] available for the ImageJ software [23] to the unrolled slice. The contour limit of each hole area is visible in the insert of the right panel of figure 7 and drawn in the image as a solid red line. Table 1 shows the outcome of the analysis where we report the area of each pipe hole in square millimetres obtained by computing the number of pixels falling within each contour, its error set to be equal at the area of one pixel, the ellipse aspect ratio, and ellipse roundness after fitting the contour with an ellipsoidal function.

Figure 7. (Left panel) Virtual unrolling direction of the analysed CT volume for the section of component in figure 6 together with the indication where the slice from the unrolled volume has been taken, and reported as a dash green line in the image. (Right panel) Slice of the unrolled volume used to quantify the area of the cooling pipe holes in the DEMO divertor mock-up. The insert in figure shows the contour limit of each hole area computed by means of ‘analyze particles’ plugin [22] available for ImageJ software [23].
