The role of construction history in safety assessments: A case study of reinforced concrete “Gerber” bridges in Italy

S. Mornati & I. Giannetti

Università degli Studi di Roma “Tor Vergata”, Rome, Italy

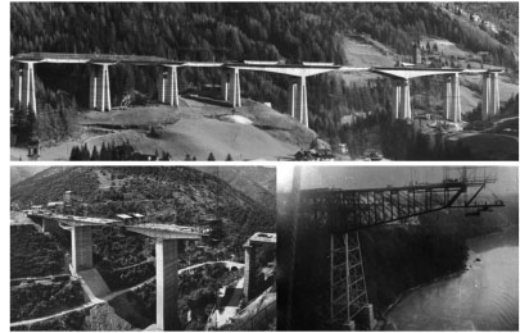
Figure 6. Colle Isarco viaduct, 1962 (courtesy of the Fondazione Gentilini); Velino viaduct, 1963 (Zorzi 1963); Niagara viaduct, 1895.

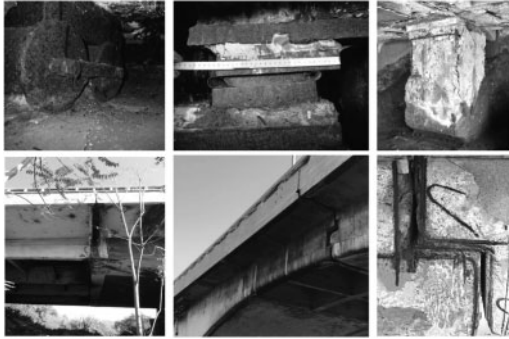
Figure 7. Detail of deterioration in supporting device and reinforced concrete half-joint (courtesy of Rome Municipal Archive, Bridge Office and Micheloni et al. 2018).

judged “incorrect” from 1992 (CNR, 1992, 10037/86) onwards, when the STM was ruled under the Eurocode 2 (EN 1992-1-2:2004), this arrangement is, thus, considered as a crucial cause of structural vulnerability of for existing Gerber bridges (Desnerck 2018).

The vulnerability of Gerber schemes has numerous aging time-related causes. Most of them are common issues for reinforced concrete structures, such as the natural aging of the materials (with particular regard to the joints), the phenomena of carbonation of concrete with material detachments, the onset of oxidative phenomena in the steel and the consequent formation of cracking states, and the change in loading conditions. Others are, instead, specifically related to the Gerber bridge half-joint shape: leakage of water through the joint causing deterioration of the concrete and corrosion of the reinforcing steel and errors during execution, such as misalignment between the cantilever extremes, are very common (Figure 7). Furthermore, even half-joint elements, placed on the protruding nib of the structural element, are particularly subject to premature aging, causing dangerous discontinuities in the road surface that, due to even contained disruption, alter driving comfort. In the context of this joint deterioration phenomena, it is necessary to understand how Gerber half-joints were built in Italy and whether it is possible to trace the adoption of some recurrent details or solutions. In executive practice, indeed, the use of metal devices (hinges, pendulums, rollers) derived from metallic construction practices was combined with the extensive use of lead sheets, steel plates and the design of special reinforced concrete pendulums devices (Cestelli Guidi 1949, Malerba 2018).
