Are tungsten-based nuclear fusion components truly invisible to x-ray inspection?

To cite this article: Triestino Minniti and Heather Lewtas 2022 *Nucl. Fusion* **62** 066003

UKAEA-United Kingdom Atomic Energy Authority, Culham Science Centre, Abingdon, OX14 3DB, United Kingdom of Great Britain and Northern Ireland

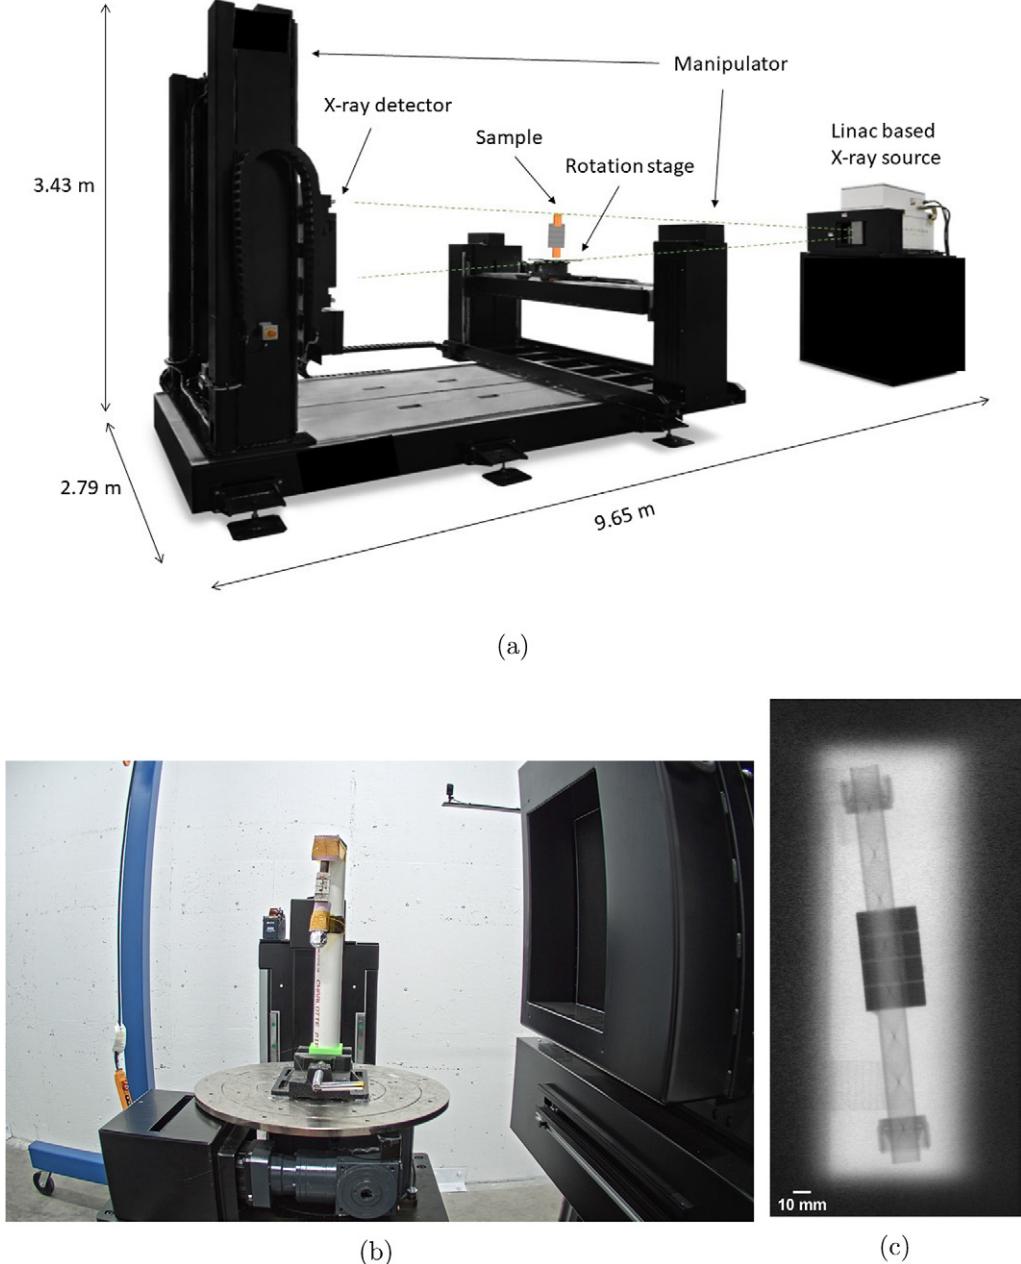
Figure 2. (a) A schematic of the facility which includes a linac-based x-ray source, a manipulator, and the x-ray detector. The dimensions of the facility are $9.65\text{ m} \times 2.79\text{ m} \times 3.43\text{ m}$ ($L \times W \times H$) at the net of the shielding construction which is surrounding it. The image shown is reproduced with the permission of NSI. (b) Detailed view of the sample setup mounted on the rotation stage of the manipulator. (c) Image of the sample at 0° angle as acquired in the tomography scan.

The sample was fixed on the rotating platform using a plastic tube which is weakly interacting with high-energy photons as shown in figure 2(b). The detection system consisted of a flat panel digital x-ray detector based on linear diode array (LDA) with 3072×3072 pixels and a pixel pitch of $139\text{ }\mu\text{m}$. A cone beam geometry and a magnification of 1.107 was chosen assuring with a beam focal spot of 1.3 mm a geometrical unsharpness U_g of the specimen at the image plane of $119\text{ }\mu\text{m}$. The tomography of the sample was collected by performing a uniformly spaced angular scan of 720 projections in the range $[0^\circ, 360^\circ]$ with a total acquisition time of 4 h. An image of

the sample acquired at 0° angle during the tomography scan is shown in figure 2(c). No normalization correction has been applied to the image which has been only cropped for a better visualization. Additionally, a few images were taken for normalization purposes (three flat field and one dark field images) prior to starting the scan. The acquired projections largely satisfied by a factor of 1.7 the minimum number of required images necessary to fulfill the Nyquist–Shannon sampling theorem [19]. The computed tomography (CT) reconstruction of the sample was performed by filtered back projection (FBP) [19] using the NeuTomPy toolbox [20] software.
